DEATH OF A BATTLESHIP
THE LOSS OF HMS *PRINCE OF WALES*
December 10, 1941

A Marine Forensics
Analysis of the Sinking

Garzke - Dulin - Denlay

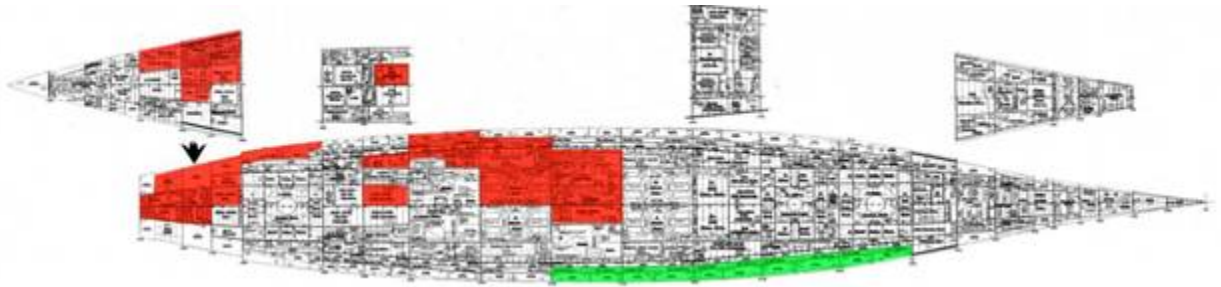
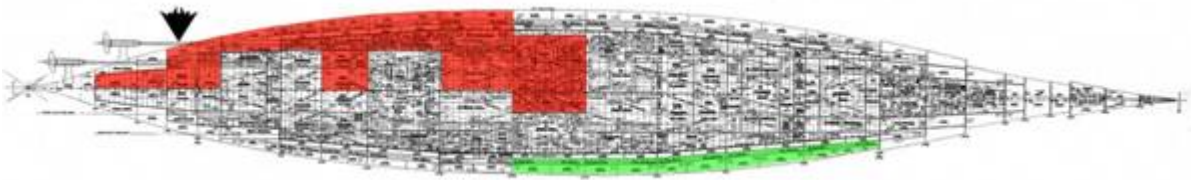
Figure 4 – Flooding Diagrams after First Torpedo Hit

The black arrow head denotes where the first torpedo struck. The red areas in the above lower-level diagrams (Hold, Platforms, and Lower Deck) of *Prince of Wales* denote the areas in the ship that were flooded after the first torpedo strike. The green area is the section of the starboard Side Protection System that was intentionally flooded to try to correct the list and trim after the massive influx of water to port.

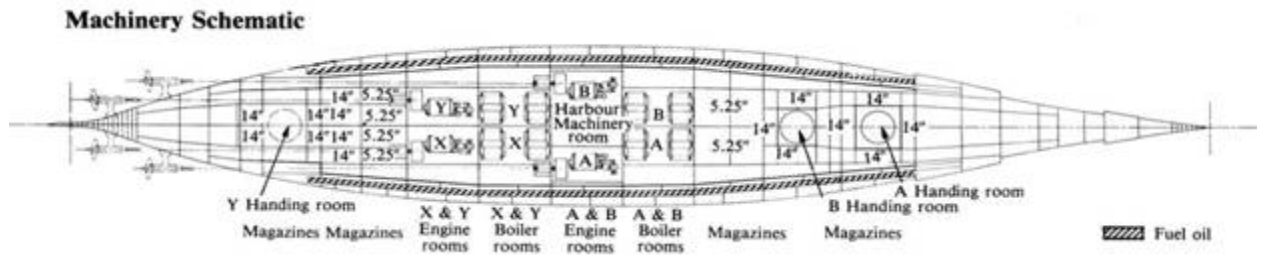
Figure 4a – Machinery and Magazine Arrangements Schematic

The above schematic shows the layout of Boiler Room and Engine Room machinery spaces and the various Magazines for the 5.25-inch and 14-inch guns in relation to one another. Also note how the center section of the “triple layered” Side Protection System was filled with Fuel Oil.

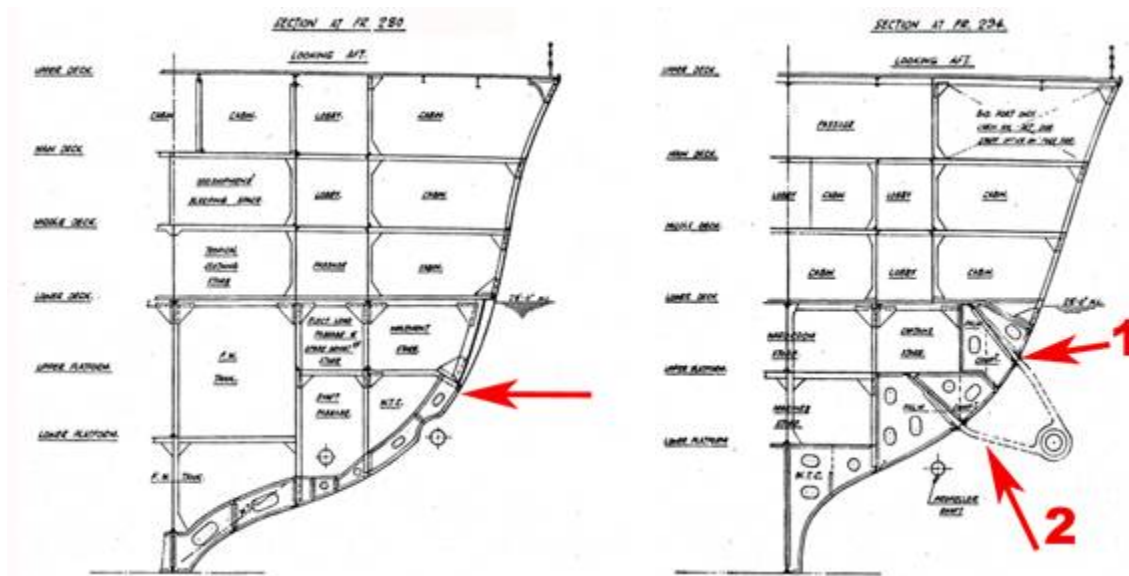
Figure 4c – Cross Sections of Port Hull in Way of Torpedo Hit

Cross sections of port hull at Frames 280 and 294, *looking aft*. **Left**. The torpedo struck at about Frame 280 just above the outer port propeller shaft (red arrow). **Right**. Frame 294. The outer strut arm (1) of the outer strut eventually broke off flush with the hull while the inner strut arm (2) broke in half. (Note: The later hit above the starboard outer strut broke its arms in the opposite manner, i.e. the outer strut arm broke in half, while the inner strut arm broke off flush with the hull.)

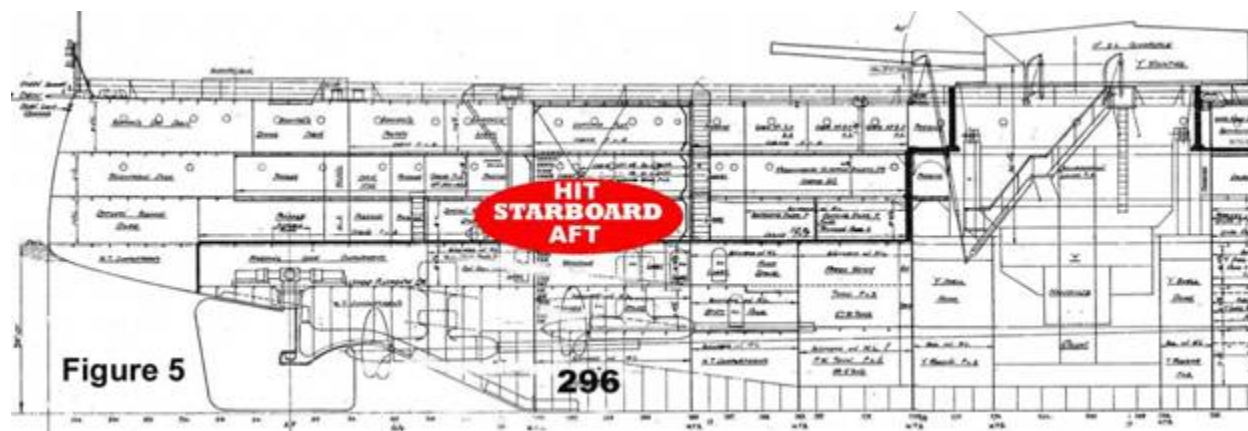
Figure 5 – Location of Torpedo Hit on Starboard Side Aft

The most devastating hit from the torpedo attack on the starboard side occurred abaft of "Y" Turret, leaving a hole approximately eleven meters long and four meters high in the hull (Figure 5) and immediately jamming the starboard outer shaft. The result was that the turbines in "A" Engine Room driving this outer shaft came to a complete and abrupt halt. Only the inner starboard shaft was now in operation. In 1966 and again in 2007, divers examining the wreckage found the outer shaft (44.5cm dia.) was bent inboard to the extent that its propeller was wedged over the inner shaft. The fact that the outer shaft was bent inboard and the propeller is wedged over the inner shaft and between the keel plate meant that the outboard shaft strut failed, and on inspection in May 2007 the outer strut arm of the outer strut was seen to have snapped in half.

Prior to these three hits to starboard it was thought by some that there was at least a chance the ship could be saved; however we now know from examining the photos of the extensive damage seen right throughout the port outer shaft tunnel (Challen 2009), that this was almost certainly not the case. As can be deduced by how high 'up' the starboard hull-side (Figures 5, 5a and 10) the after-most torpedo impacted *Prince of Wales*, her stern had to have

Of the three starboard hits the after-most one was the most serious (*the after-most hole is centered at approximately Frame 296, Figure 5*), the forward two being somewhat superfluous in the cause of her demise.

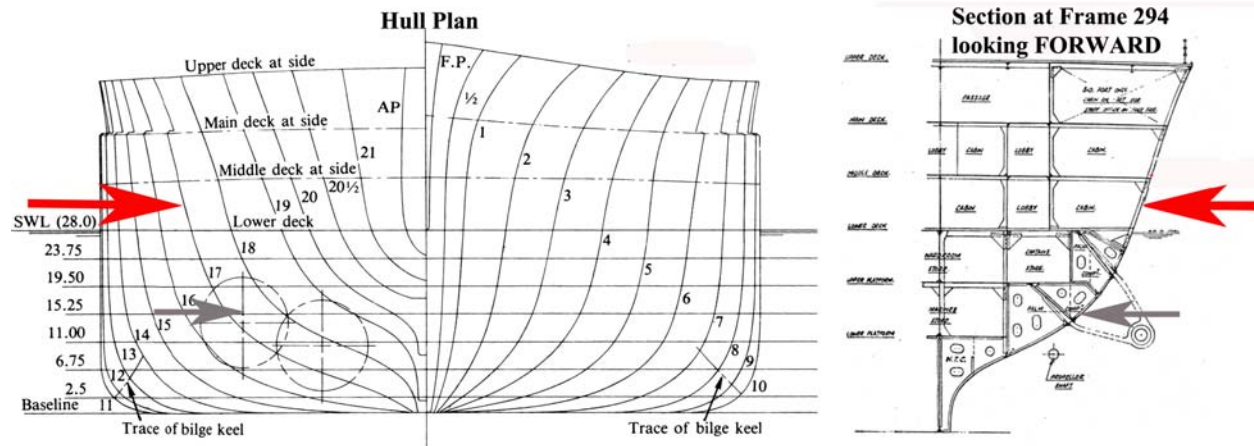
Figure 5a – Height of the Torpedo Hit on Starboard Side Aft

already settled perilously low for this torpedo to have struck as high (on the hull) as it did. This was the result (of the flooding) from the single torpedo hit well aft on the port side that had resulted in a “mobility kill”; it not only wrecked the effectiveness of *Prince of Wales* as a combatant, it had also effectively sealed her doom through progressive flooding.

The RED arrows above points to the approximate location of the STARBOARD aft torpedo hit. For comparison the smaller GREY arrows points to where the first torpedo hit on the PORT side aft. Note how much higher on the hull the starboard torpedo impacted, which gives an indication of just how far the stern had settled in the thirty five minute interim between the port and starboard aft hits.

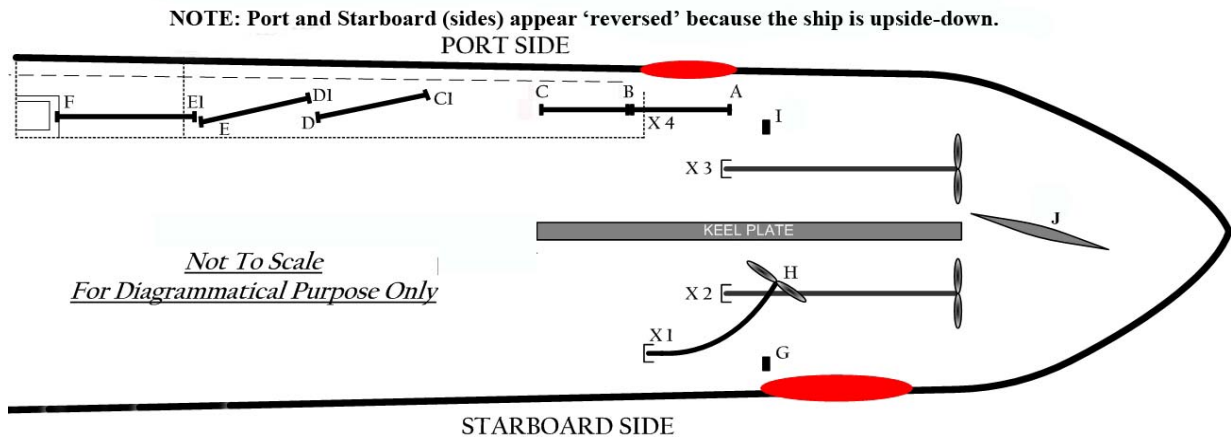
Figure 6 – Illustration of Propeller Shafts inc. Interior of Port Outer Shaft Tunnel

The three torpedo hits on the starboard side nevertheless seriously added to *Prince of Wales* woes, especially the after-most hit, as it negated all the damage-control efforts to complete a flooding boundary in the stern. The flooding they caused did, however, help reduce the list to port from nine degrees (as it was before the three starboard hits) to three degrees. The draft of the ship now increased significantly though, leading to further uncontrollable progressive flooding. With the both outer shafts damaged and the port inner shaft not operational, the ship’s speed was cut to 8 knots. (See Figure 6 for the status of shafting as surveyed in 2007, 2008 and 2009.)

The illustration shows the after part of the upside down HMS *Prince of Wales* as surveyed by divers in 2007, 2008 and 2009. Label F is the dislocated flange at the Thrust Block. E1 is the flange at the opposite end of that length of shafting which protrudes about half a meter through the elongated gland of the partially intact aft bulkhead of the Diesel Dynamo Room. (F, E1/E, D1/D, C1/C and A are all flanges that have separated, while B is the only flange still intact.) The line shafting E-D1 (and the forward third of the shafting D-C1) are the sections of shafting found in “Y” Action Machinery Room. The position where the intact flange marked B is now is where the stern tube would have been. (Although the hull in this area is now heavily damaged, X4 is the approximate point where the shafting would have originally exited the hull). X1, X2 and X3 are where the three remaining shafts exit the hull. Labels I and G are the short stubs that remain of, respectively, the inner and outer Strut (A-Bracket) arms for the outer propeller shafts. Label H is the current position of the starboard outer propeller and shaft. Label J is the current position of the rudder, the leading edge pointing off-center at an angle of approximately 20 degrees towards the port hull; which indicates a turn to starboard. The ship however was turning to port when hit, so how or when the rudder angle was altered is currently unknown. The red ellipses show the actual positional relationship of the torpedo holes to the shaft and propeller locations and the size of the holes relative to one another.

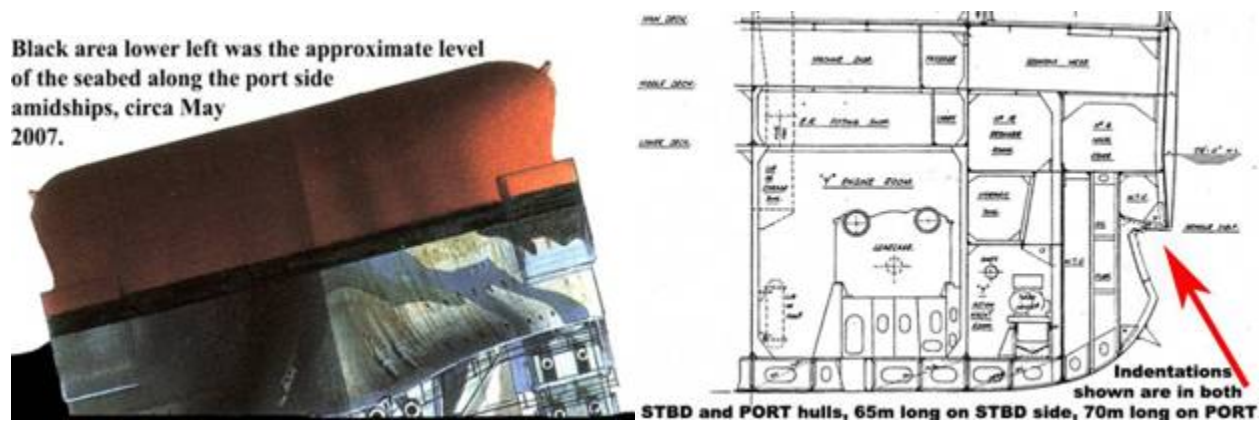
Figure 7 – Prince of Wales at Rest on the Seabed

The 2007 survey also discovered that there was significant longitudinal indentation of the hull plating for 65 meters along the hull on the starboard side of the ship and for 70 meters along the port side hull as well. (Figure 7) This leads to the conclusion that non-contact explosions, either from ‘near-miss’ bombs or torpedoes, caused considerable indentation on both sides of the ship and flooding of the outer voids through failed riveted seams; as these indentations could not result from the ‘implosion phenomenon’ as most of these areas were already flooded prior to sinking. Some of the indentations closely resemble the damage that *Prince of Wales* sustained from a near miss 250-kilogram bomb that exploded ten feet (three meters) from the ship’s port

Gunners Mate Alan McIvor of *Prince of Wales* (P3 5.25" turret) has never forgotten this bomb attack. He recalled: “*I was standing at the open entrance to our turret; suddenly there were three tremendous explosions, the force of which threw me back inside. I soon realised I’d been very lucky, for the shock of these detonations lifted our gun turret off its trunion²¹, and I’m certain if I hadn’t been sheltered from the main blast, I wouldn’t be here today.*” The other six bombs exploded close to *Prince of Wales* and caused both splinter and water-hammer damage, resulting in indentations in the hull plating that can be seen on both sides of the wreck today, which in turn led to additional flooding due to popped rivets and failed seams in riveted joints. (Figures 7, 9, 10.)

Prince of Wales rests upside-down at a depth of 68-meters and is tilted over on an angle of between 15 and 20 degrees to her port side, with the starboard deck edge about 5.5-meters up off the seabed at its highest point amidships. The Expedition ‘Job 74’ diving team found a 65-meter long concave indentation on the starboard hull and a 70-meter long concave indentation on the port hull just below the side armour belt during their survey of the hull in May 2007 (see also Figures 9 and 10). As shown in the above diagrams the indentations are very concave just below the armor belt, the concavity gradually decreasing down from the armor belt to a point just above the bilge keel. There is also a distinct ‘knuckling’ of the hull in several places along both port and starboard indentation areas, and very noticeable longitudinal splitting of seams along almost their entire length. (The original survey reports of said hull damage can be accessed in their entirety via the web links listed on page 79 of this paper.)

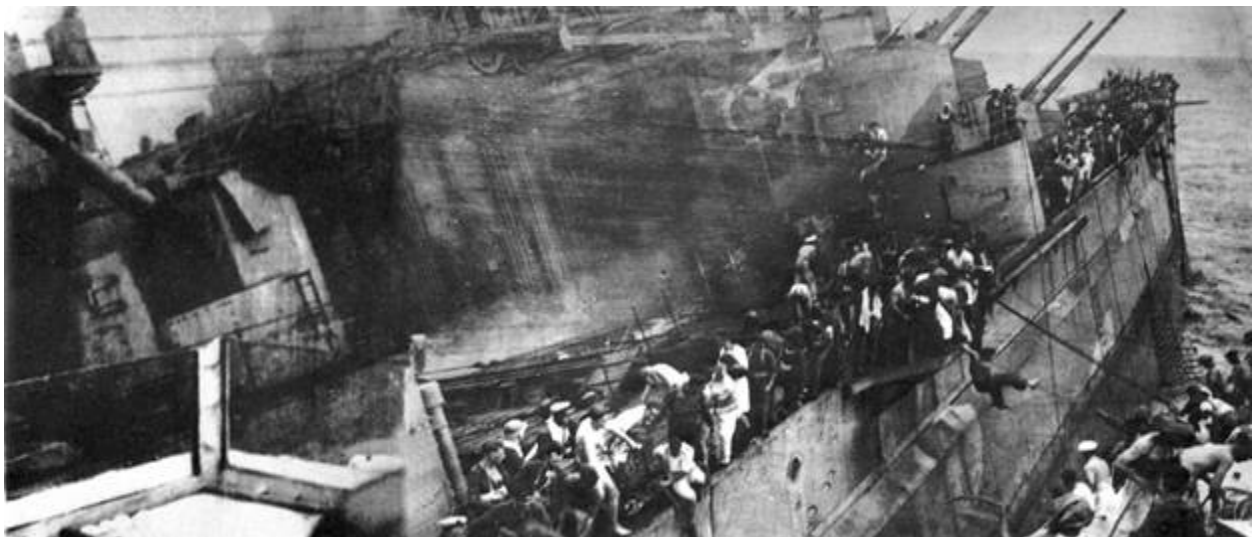
This image is a composite by the author of two photos taken from the destroyer *Express* that came alongside the starboard side to evacuate personnel off *Prince of Wales*. When the battleship capsized, her starboard bilge keel came up underneath the destroyer, causing *Express* to take a very large roll to starboard. Note the high elevation of S1 and S2’s 5.25-inch guns (far right) that had fired at the Japanese bombers during the attack at 1244. (Interestingly, the barrels of S2 were found to have snapped off on impact with the sea bed after the ship capsized (see photo page 27), while the barrels of S3 (far left) were not visible during Expedition ‘Job 74, having either snapped off and/or were buried under the seabed.)

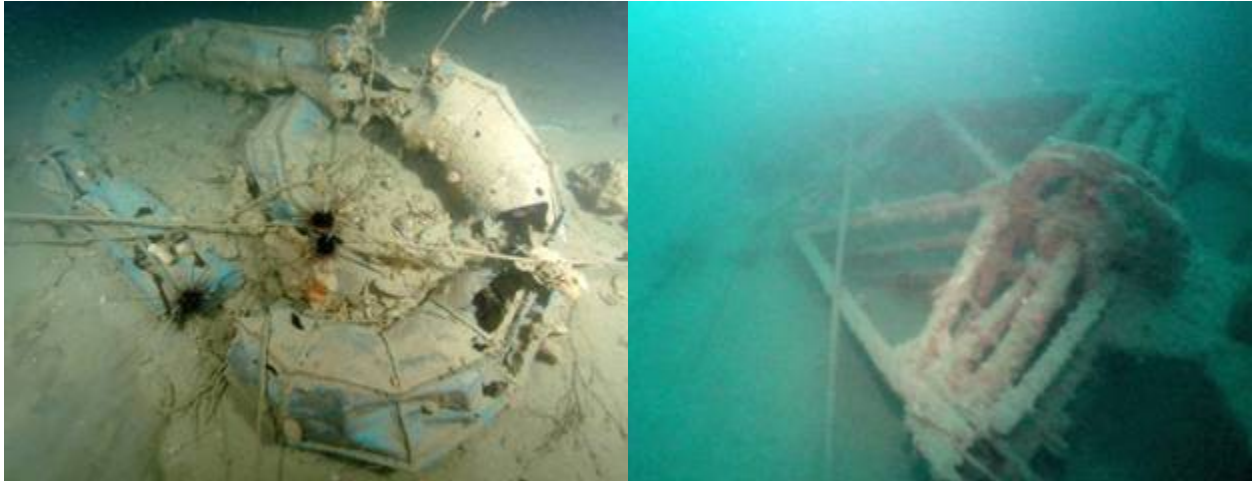
Left. The remains of a Carley float on the seabed near S2 turret. **Right.** A section of the *starboard* aircraft / boat crane lays on the seabed next to the wreck abreast the catapult deck.

The catapult area is ‘open’ approximately halfway across towards the port side (about a meter or more past the starboard turntable) to where sand has built up over time preventing further exploration in that direction. Several Carley floats (life rafts) can be seen on the seabed beneath the starboard deck near S2 turret, and a small section of a crane lies just outboard from the edge of the wreck in this area also.

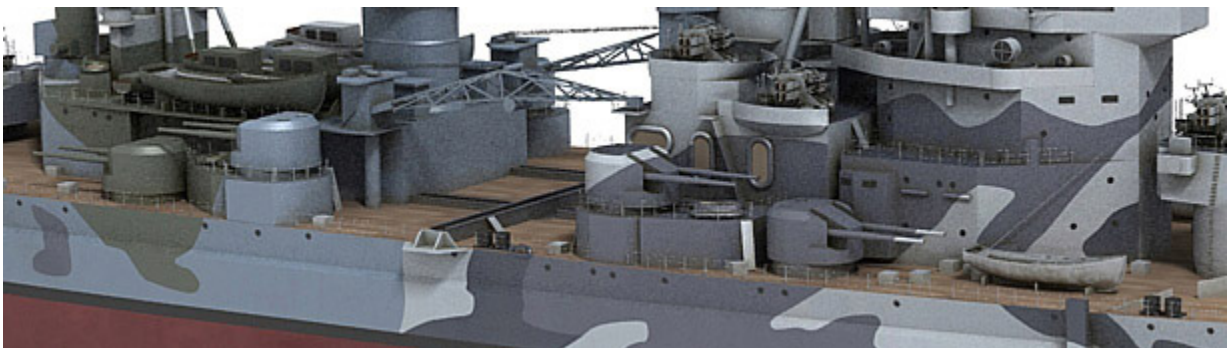
Turret S2 is partially buried in the sand with its casemate and most of the mounting exposed. However, when the ship struck the seabed, the guns broke away from the mounting and now lay beside it on the seabed. This turret is trained forward, pointing off the starboard bow. Turret S1 is well clear of the sand with its guns intact and is also pointed off the starboard bow.

The four starboard 5.25” guns that can be seen on the wreck, right to left, S1, S2, S3, S4.

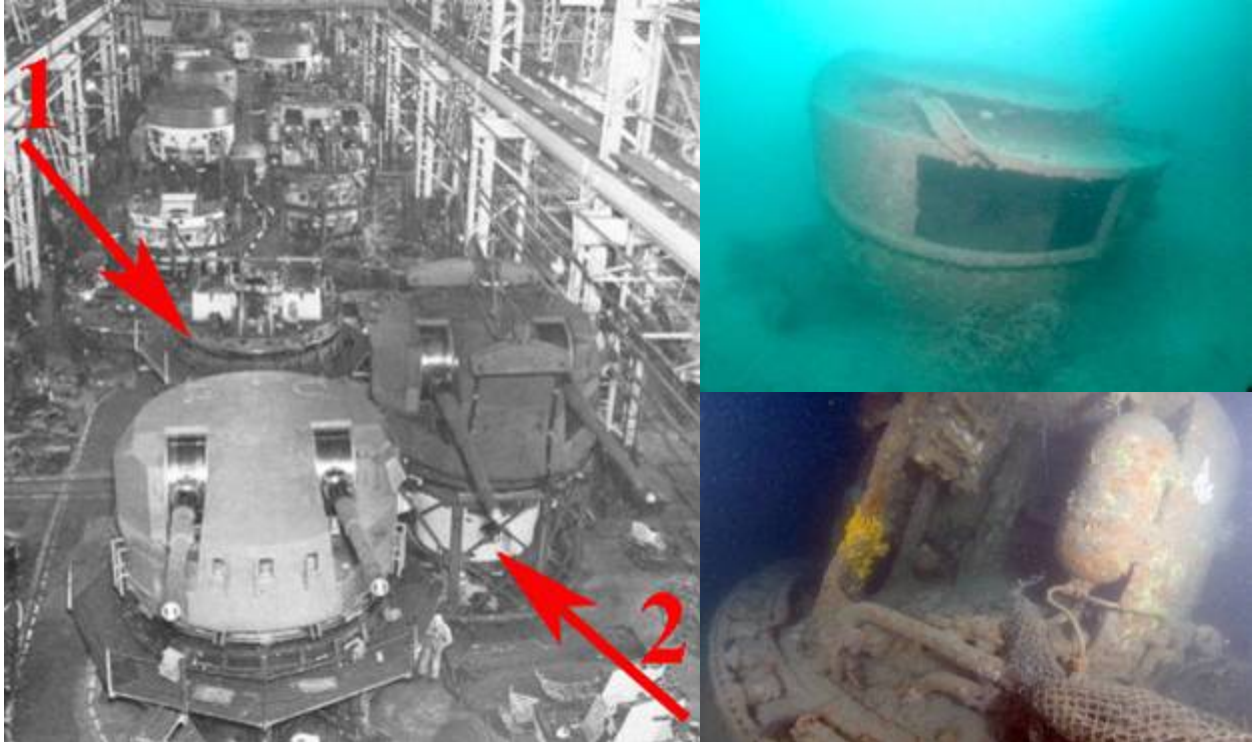
Between the starboard hull and the displaced cranes’ location on the seabed is what appears to be one of the port 5.25-inch turrets inverted in the sand (most likely P3) with its rotating ring and working chamber clearly exposed; although the gun chamber itself is completely buried under the sea floor. The only explanation for this structure being there on the seabed is that it must have ‘fallen out’ from its deck location when the ship capsized. We now know that the foundation for this turret was damaged by the 500-kilogram bomb hit, which in turn allowed it - and the adjacent crane - to fall off during the capsizing process. (Note the statement of P3 Gunners Mate McIvor - page 33 - that the force of the nearby bomb explosion “*lifted our gun turret off its trunion*” (or more precisely “*off its roller ring*”).)

Left. Twin barreled 5.25-inch dual-purpose turrets under construction at the Vickers Armstrong facility. Note the incomplete turret's rotating roller ring in the background left (1) and the working chamber beneath the turret on right (2). For scale comparison note the man standing to the left of arrow 2. **Top right.** The inverted 'working chamber' on the seabed as seen if approached from astern. **Bottom right.** A close-up of the chamber, but as seen when approached from forward; note the 'roller ring' at bottom left.

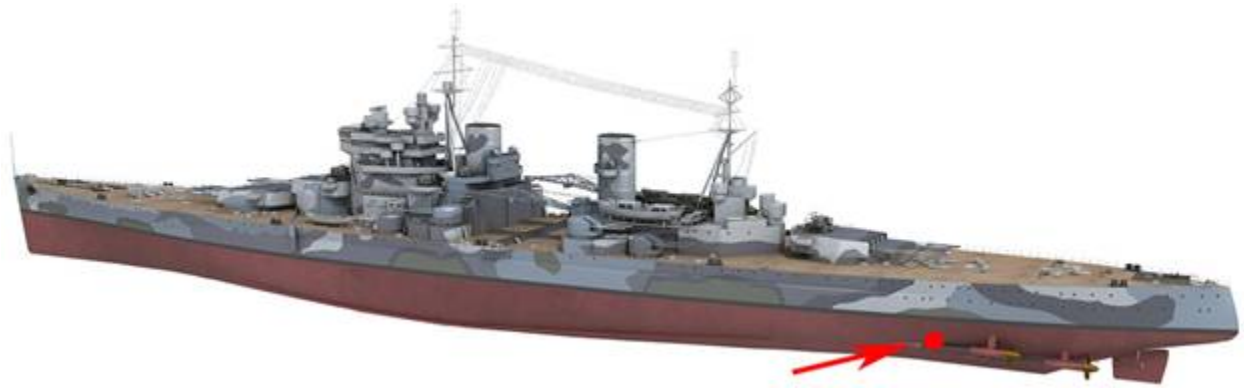
On the port side aft there is a single torpedo hole approximately 4 meters high and 6 meters long extending aft from just forward of where the outer shaft exited the stern tube gland (this hole is centered at approximately Frame 280, Figure 1):

The initial damage was mainly confined to the outer hull structure, strut, and propeller. However, damage from the torpedo explosion also extended into the ship and forward into the outer stern tube receptacle, and the damage there was particularly devastating. No ascending water column was seen from this hit (apparently because of its location well under the hull).

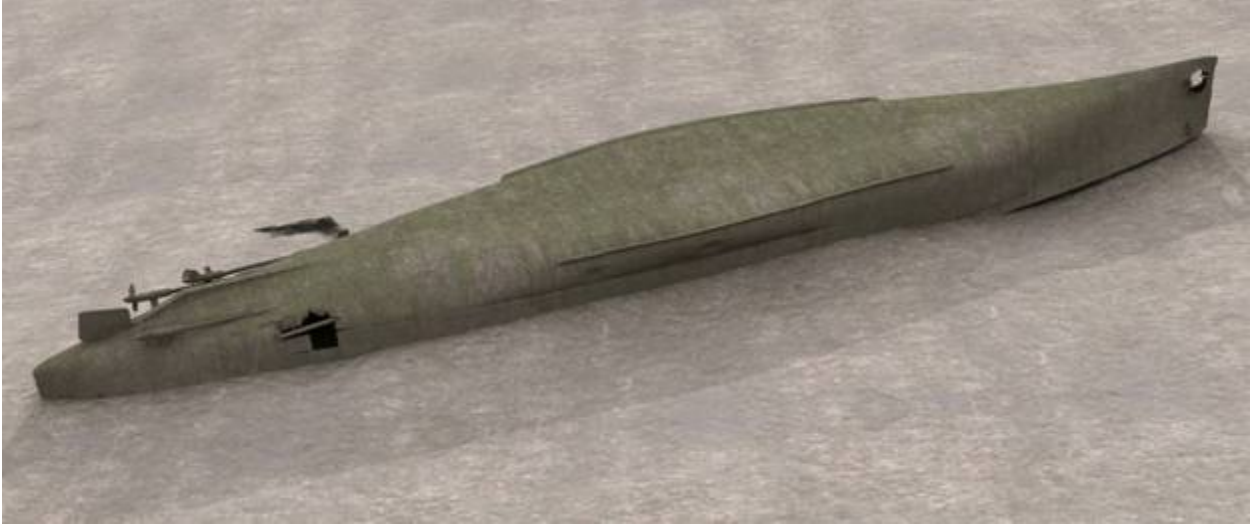
- a) The blades of the propeller for the port inner shaft are missing large pieces of their edges, indicating that they were struck by debris from the initial torpedo explosion or by either the outer propeller or other debris when it broke away.
- b) The port outer shaft has come apart at the flange about 8 meters forward from the opening in the stern tube where the shaft emerges (Flange 'A', Figure 11). The receptacle for the stern tube has been ripped open large enough for a diver to enter forward along the shaft, and has a rip – or tear - on the outboard side which extends forward about two meters. The damaged web frames in the stern tube receptacle are now clearly visible, as is the one remaining intact flange (Flange 'B', Figure 11).

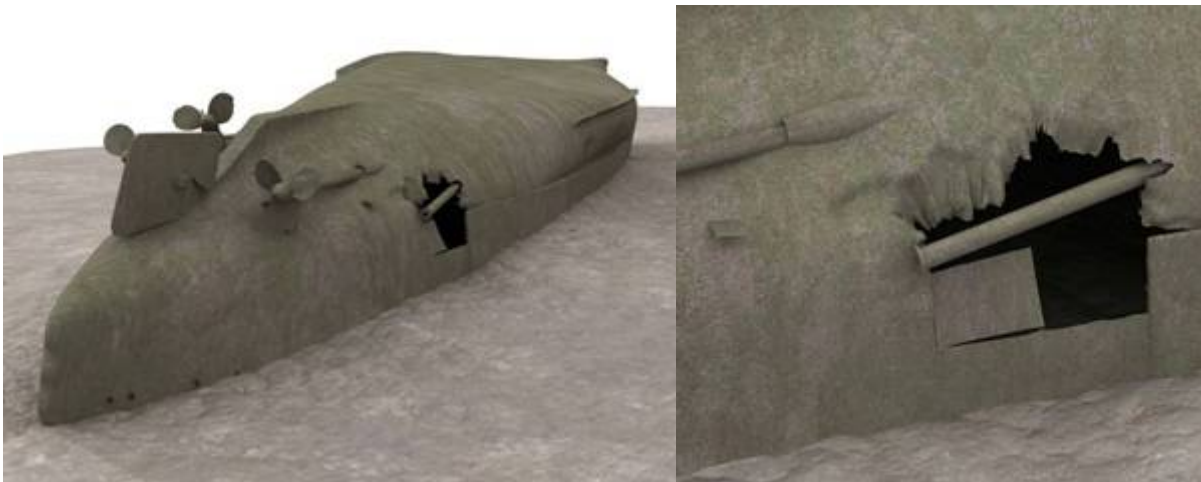
- c) There is a plate of armor collapsed inwards at the forward edge of the hole. Another plate just aft stands somewhat vertical, and appears precariously balanced. The hull forward and aft of this hole is significantly damaged and distorted for approximately 2 meters in either direction.

- d) The September 2009 excursion up the port shaft alley revealed the damage caused by the shaft rotating out of center, which was caused by torpedo damage to the stern tube, propeller shaft, and strut. The holes in transverse bulkheads at Frames 206, 228, 242, and 253 are huge, some 4-6 feet in diameter. Several hatches were discovered opened either from the intense water pressure or left opened by escaping crew. In the latter case, if the hatch had been quickly dogged and not firmly closed, the water pressure would have sprung them open.

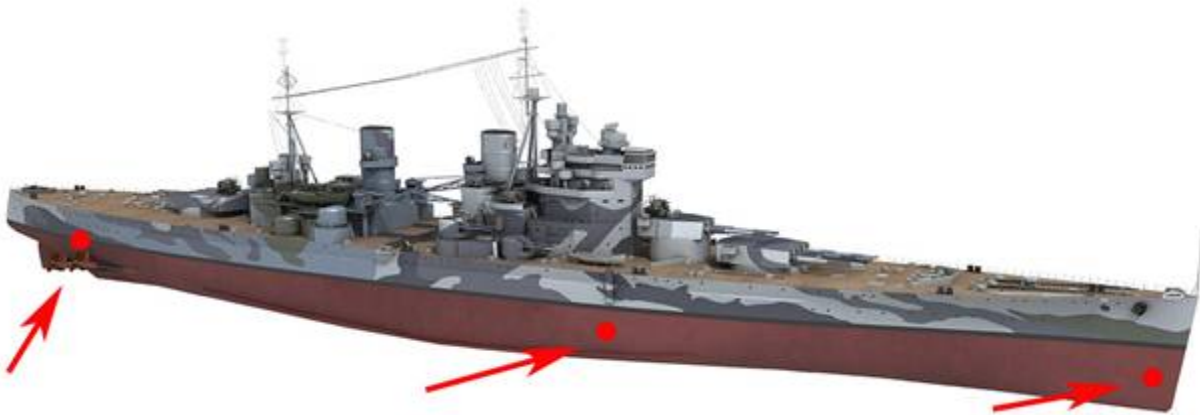
Due to their locations on the actual side of the ship – as opposed to ‘under the ship’ as the port aft hit was - these three hits exhibited the typical venting plumes, or water columns, extending high into the air after their detonations.

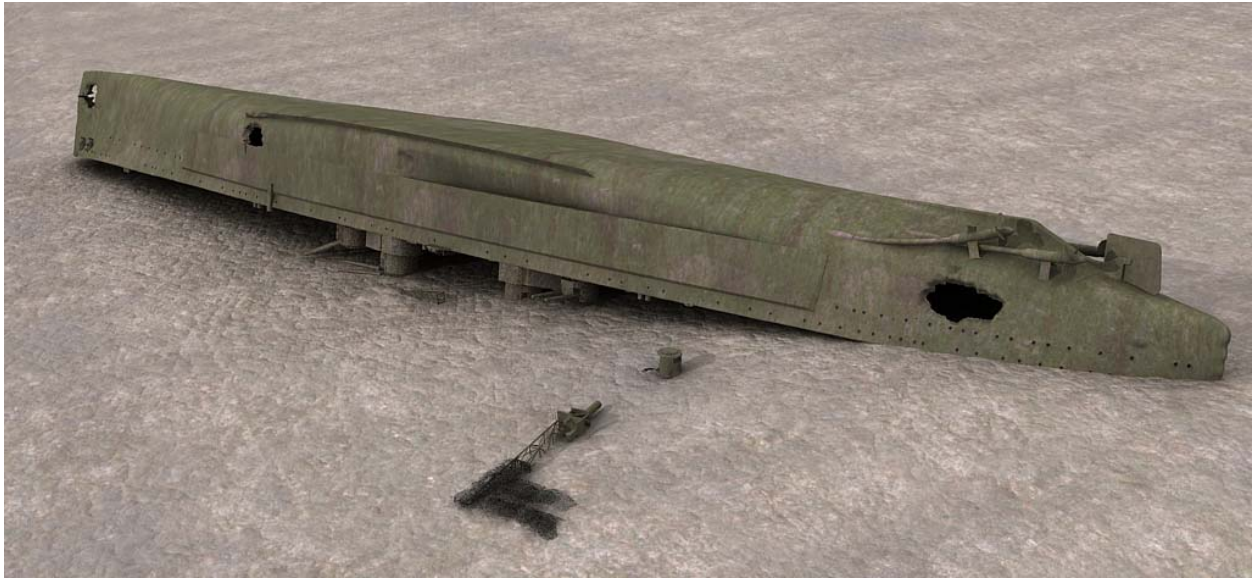
- b) There is a hole approximately 4 meters high and 11 meters long in the area of the hull above the remains of the outer shaft struts outer arm. This indicates that the torpedo struck the ship on the hull above and only just abaft the *outer* strut arm and in comparison to all the other torpedo hits, this damage is located much higher on the hull side. This also

- c) The torpedo damage extends into the ship, with decks visible inside the hole.
- d) There are rips and tears in the surrounding plates and supporting structure that have been pushed in fore and aft of the hole for about two meters in either direction.

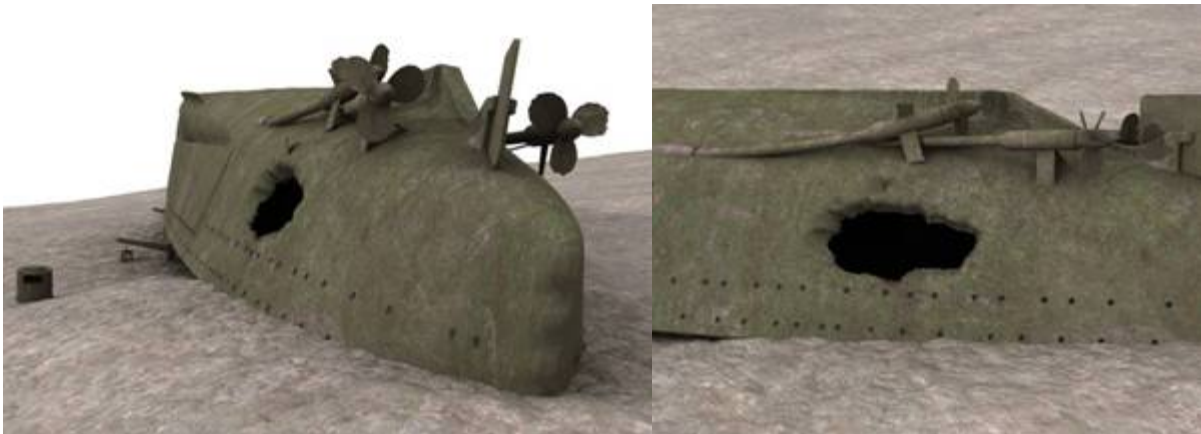
- e) The flooding boundary that had been established before this hit occurred was now destroyed. Prior to this hit, the aft end of the quarterdeck had already been precariously close to the waterline and this hit now added even further to the ‘down by the stern’ trim. As the stricken battleship trimmed down more by the stern, the quarterdeck level settled into the water. The ship’s remaining stability and buoyancy were now seriously compromised.

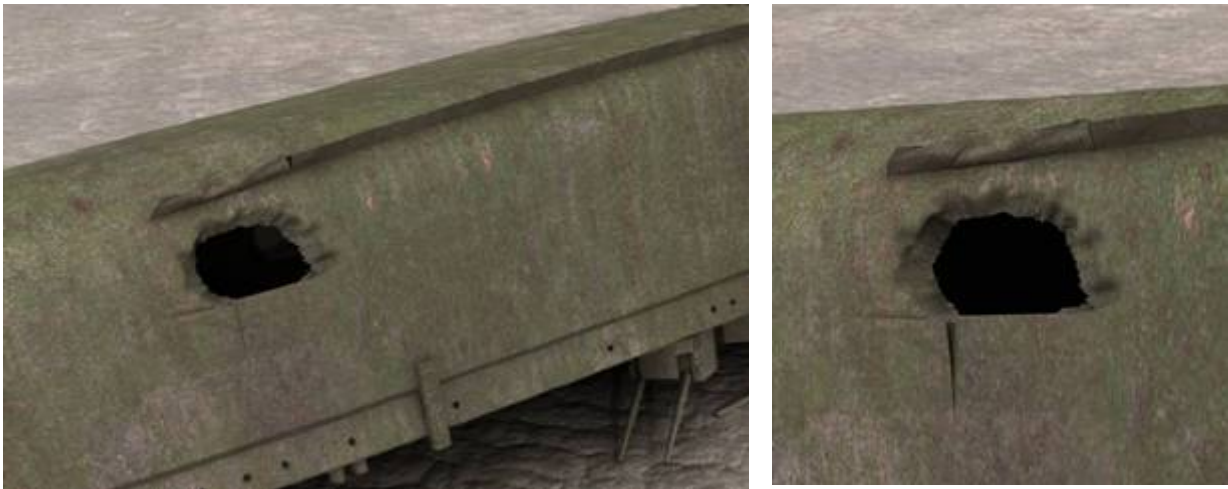
There is another hole outboard of “B” Turret on the starboard side just aft of the forward end of the bilge keel, with one ‘edge’ of the hole being at the base of the armor belt (*this hole is centered at approximately Frame 109*).

- a) The torpedo hole is approximately 4 meters high by 6 meters wide.
- b) The hit was made in way of the torpedo defense system and there appears to be no significant breach in the inboard bulkhead of the air/fuel/air sandwich layer.
- c) It also appears that the torpedo exploded just below the lower edge of the main side belt which helped to contain it and aided in venting the blast effects.
- d) There is a hole in the Middle Deck over the defense system into the Seamen’s Mess area, reported to have been caused by a degaussing generator being blown up through the deckhead.

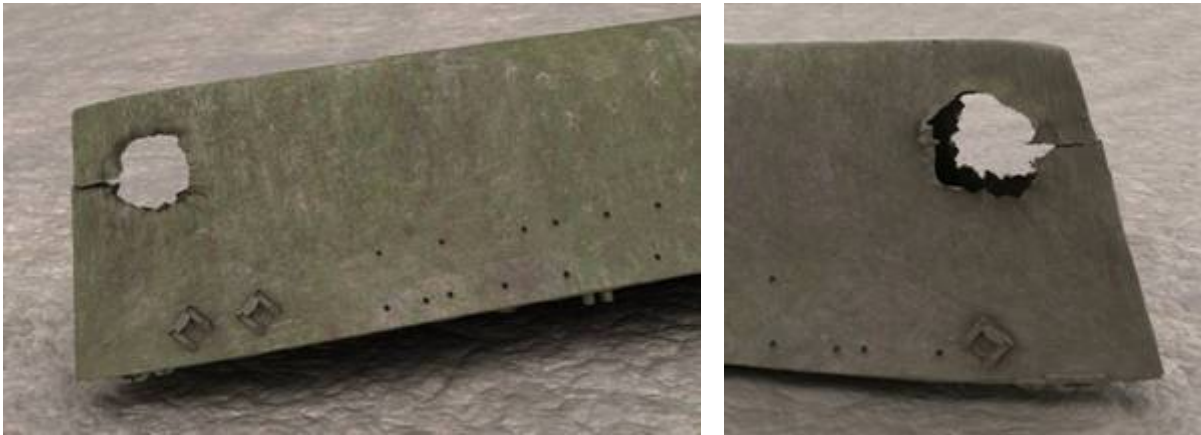
There is a ragged hole approximately 7 meters in diameter through the bow of the ship (*the hole is centered at approximately Frame 8*). The plating is bent outward to port implying a starboard torpedo explosion and the stem post is fractured, indicating just how far forward this torpedo hit. There is often a considerable amount of fouled/discarded trawler netting to be seen around this hole.

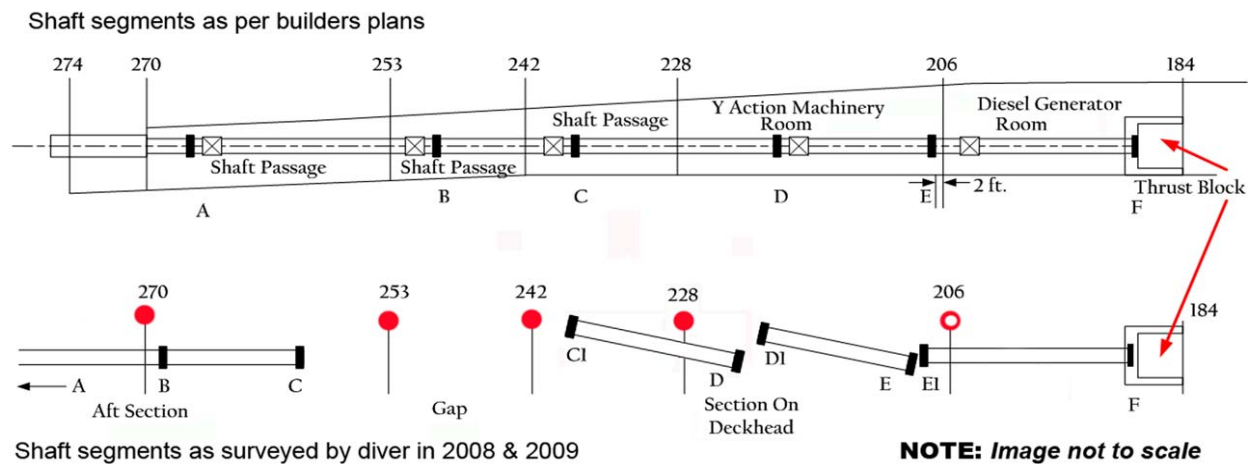
Figure 11 – Illustration Comparing the Port Outboard Propeller Shafting

A comparison of the intact port outer shaft (upper) and the separated sections as surveyed (lower), with bulkhead frames numbered and flanges marked A, B, C, D, E, F. Flange B is the *only* flange that remains intact aft of the Thrust Block itself; the length of shafting missing (approximately 17-meters) aft of Flange A having separated with the propeller when it broke away. The distance across the gap between separated Flange C is approximately 14-meters (C to C1). Solid red dots indicate the destroyed bulkheads along the shaft tunnel, while the outlined red dot (frame 206) indicates a partially destroyed bulkhead.

It is now clear that the shaft failed at the four consecutive flanges aft of the Thrust Block / Engine Room bulkhead; i.e. the forward flange in the Diesel Dynamo Room at the Thrust Block (*Flange F*), the flange in “Y” Action Machinery Room just aft of the bulkhead to the Diesel Dynamo Room (*Flange E*, *Figure 11*, inboard Frame 207), the flange *towards* the aft bulkhead of the “Y” Action Machinery Room (*Flange D* *Figure 11*, inboard Frame 221), and the *next* flange aft of “Y” Action Machinery Room (*Flange C*, *Figure 11*, inboard Frame 239). [At this point it can be seen that not only has the shaft separated at this flange, but the intact section of shaft (two lengths) further aft has also been pulled aft-wards from this flange – and partly out through the stern tube receptacle - when the separation took place.] The next flange aft of this ‘break’ remains intact (*Flange B*, *Figure 11*, inboard Frame 251), but is now situated in the damaged stern tube receptacle (*inboard of Frame 272*), i.e. approximately fourteen meters further aft than it should be located. The ‘final’ flange on the shaft, that was situated just inside the shaft passage itself also failed (*Flange A*, *Figure 11*, inboard Frame 266) and when the propeller broke away it took with it the stern tube and the approximately seventeen meters of

This, then, is the flange now seen on the end of the length of shaft protruding from the damaged stern tube receptacle that was first identified by John Roberts. So, all told, the port outer shaft parted at five separate flanges: one just forward of the stern tube, one two shaft lengths up the shaft tunnel, one at the end of the next length of shaft, one at the end of the next length of shaft where it abuts the Diesel Dynamo Room bulkhead, and one at the Thrust Block housing itself.

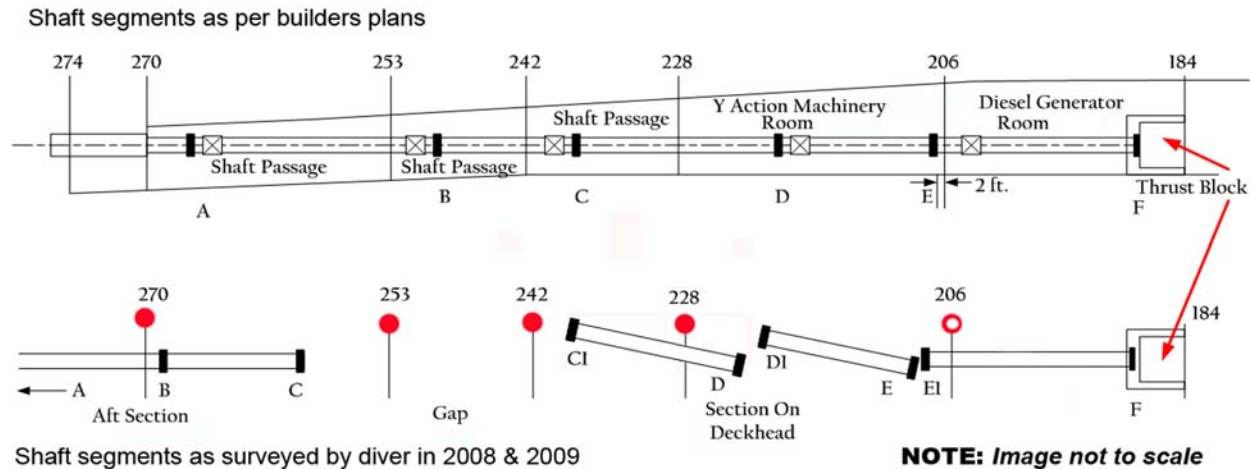
Figure 11 – Illustration Comparing the Port Outboard Propeller Shaft

A comparison of the intact port outer shaft (upper) and the separated sections as surveyed (lower), with bulkhead frames numbered and flanges marked A, B, C, D, E, F. Flange B is the *only* flange that remains intact aft of the Thrust Block itself; the length of shafting missing (approximately 17-meters) aft of Flange A having separated with the propeller when it broke away. The distance across the gap between separated Flange C is approximately 14-meters (C to C1). Solid red dots indicate the destroyed bulkheads along the shaft tunnel, while the outlined red dot (frame 206) indicates a partially destroyed bulkhead.

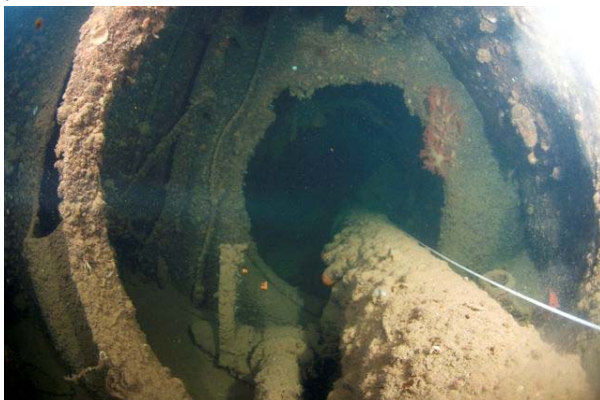
Looking forward at destroyed bulkhead at Frame 270. White 'line' right is the survey measuring tape.

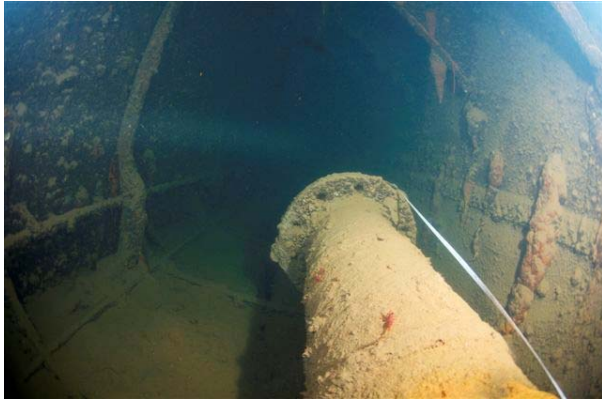
Looking towards / past Flange C.

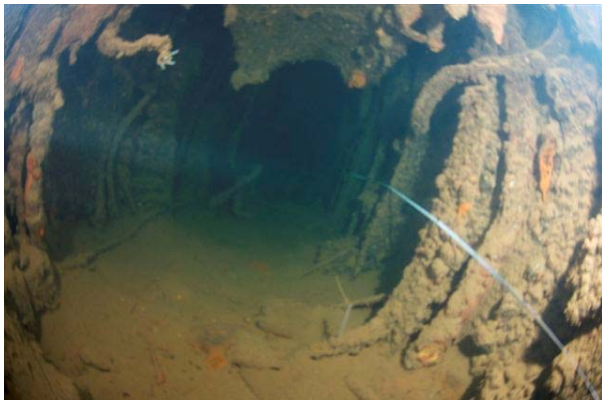
Approximately halfway between bulkhead at Frame 253 and bulkhead at Frame 242

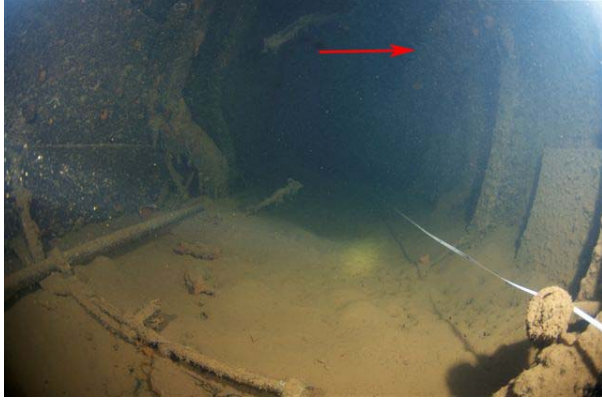
Arrow points to Flange C1, barely visible in upper right center

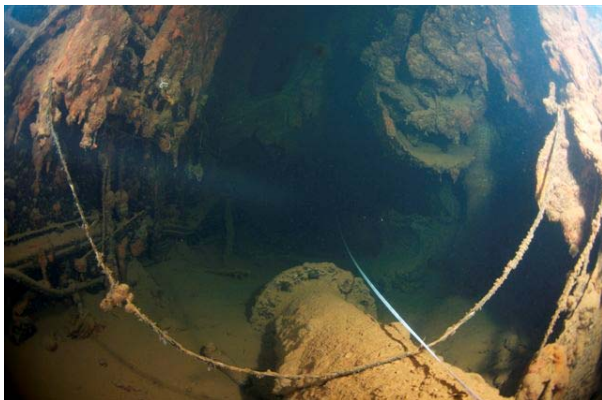
Flange D center, inside Action Machinery Room.

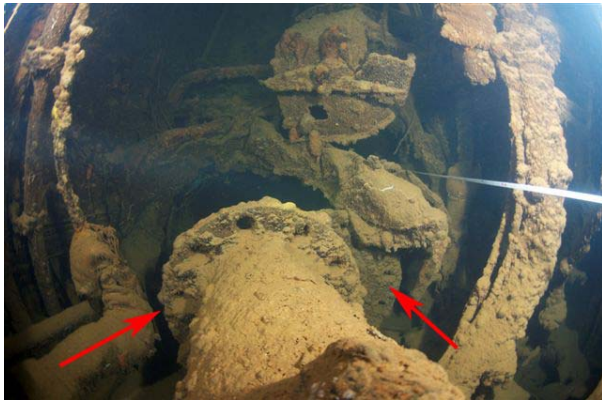
Flange E, left arrow: Flange E1, right arrow. Bulkhead at Frame 206 in background.

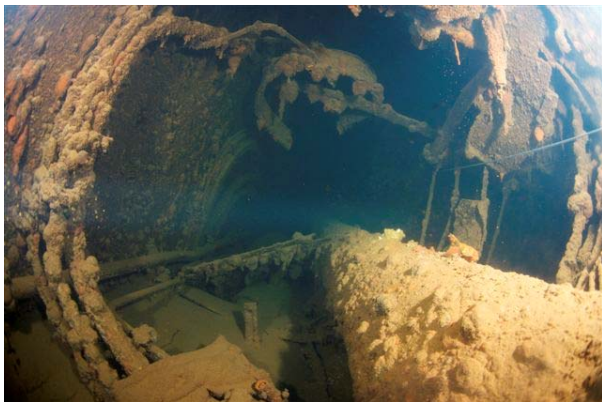
Photo taken immediately after survey diver maneuvered through elongated bulkhead gland at Frame 206

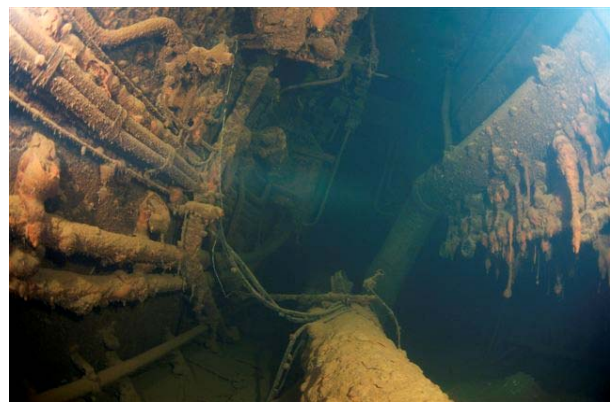
Shaft (at bottom) further into the Diesel Dynamo Room

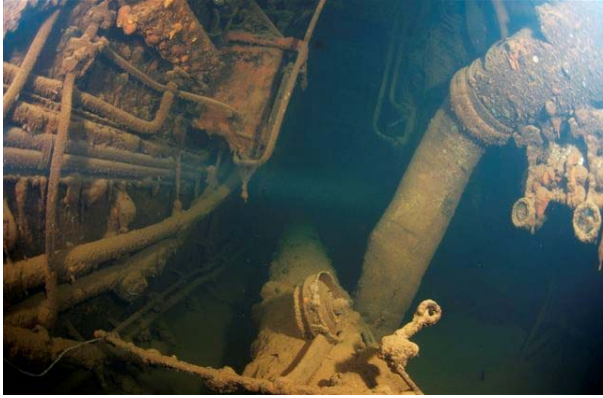
Still further inside the Diesel Dynamo Room

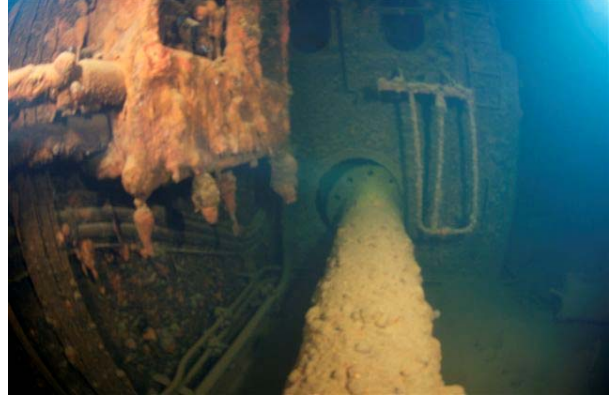
Looking further along shaft to Thrust Block enclosure

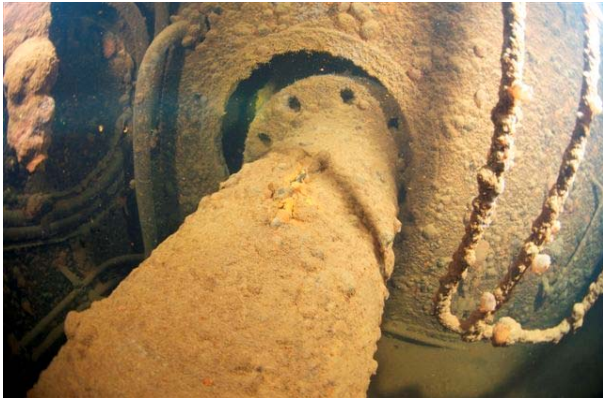
Shafting leading to dislocated Flange F inside Thrust Block enclosure

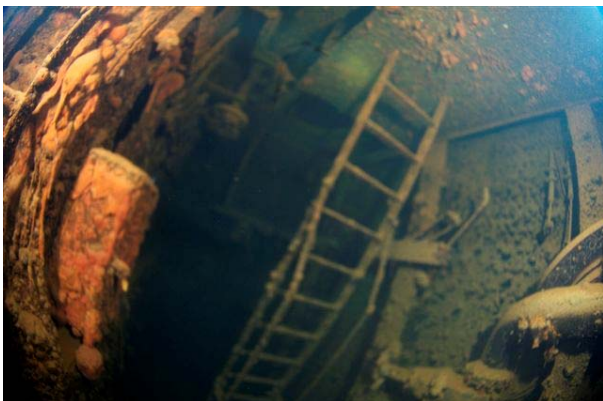
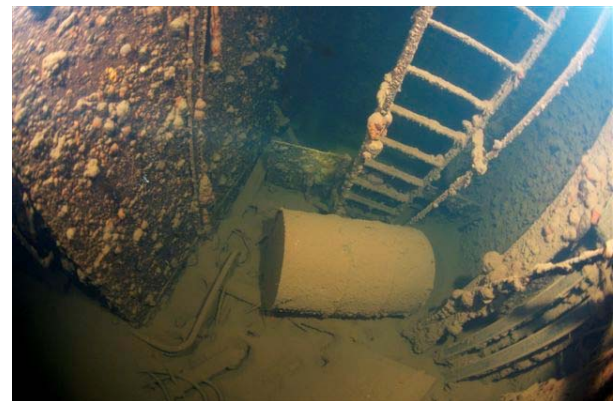
Alcove on outboard side of the Thrust Block enclosure. Behind ladder is the bulkhead to B Engine Room, Frame 184. Under the 'drum' in image on right is a deckhead hatchway.
